**AL QUDS, AL MUALAMEEN, AND
AL FAOO SCHOOLS**

**UNDER THE IRAQ-COMMANDER'S EMERGENCY
RESPONSE PROGRAM**

BAGHDAD, IRAQ

SUSTAINMENT ASSESSMENT

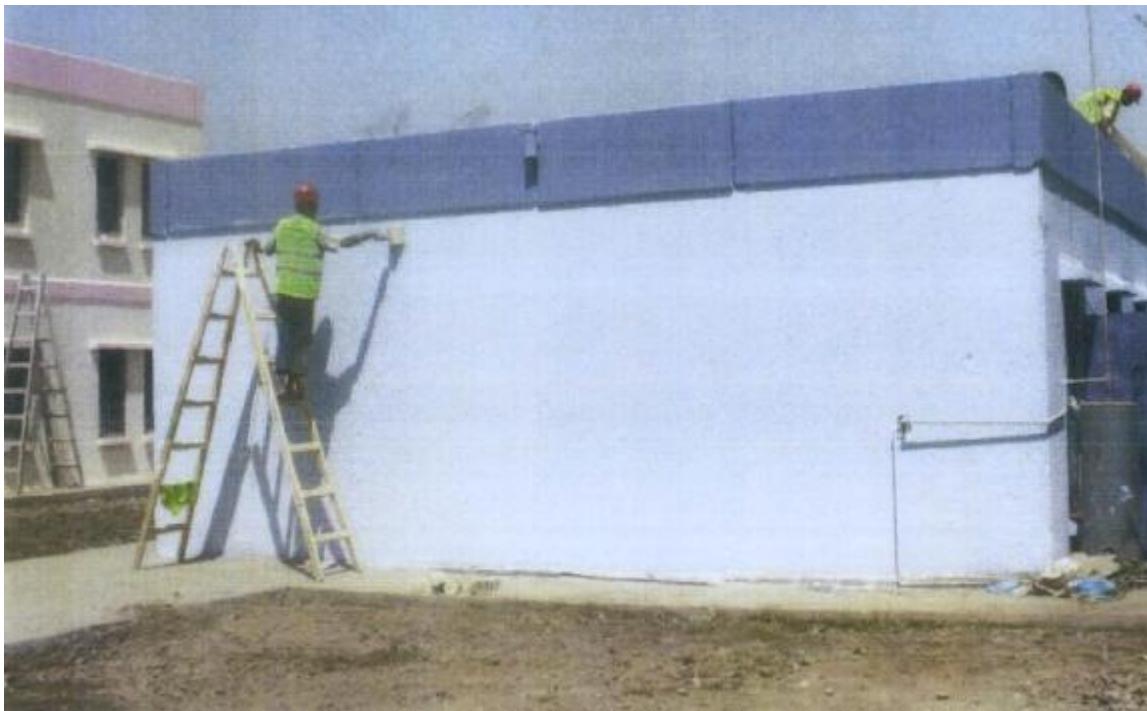
Site Photo 2. Exterior painting at Al Quds (Photo courtesy of MNC-I)

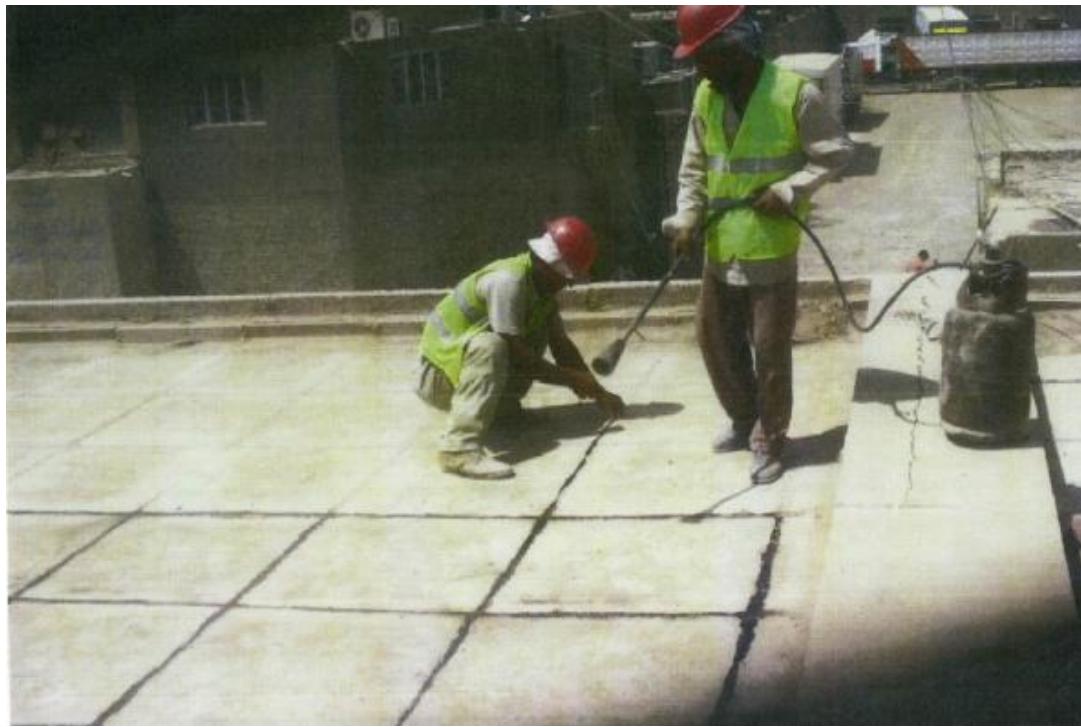
Site Photo 3. Repairing the roof at Al Quds (Photo courtesy of MNC-I)

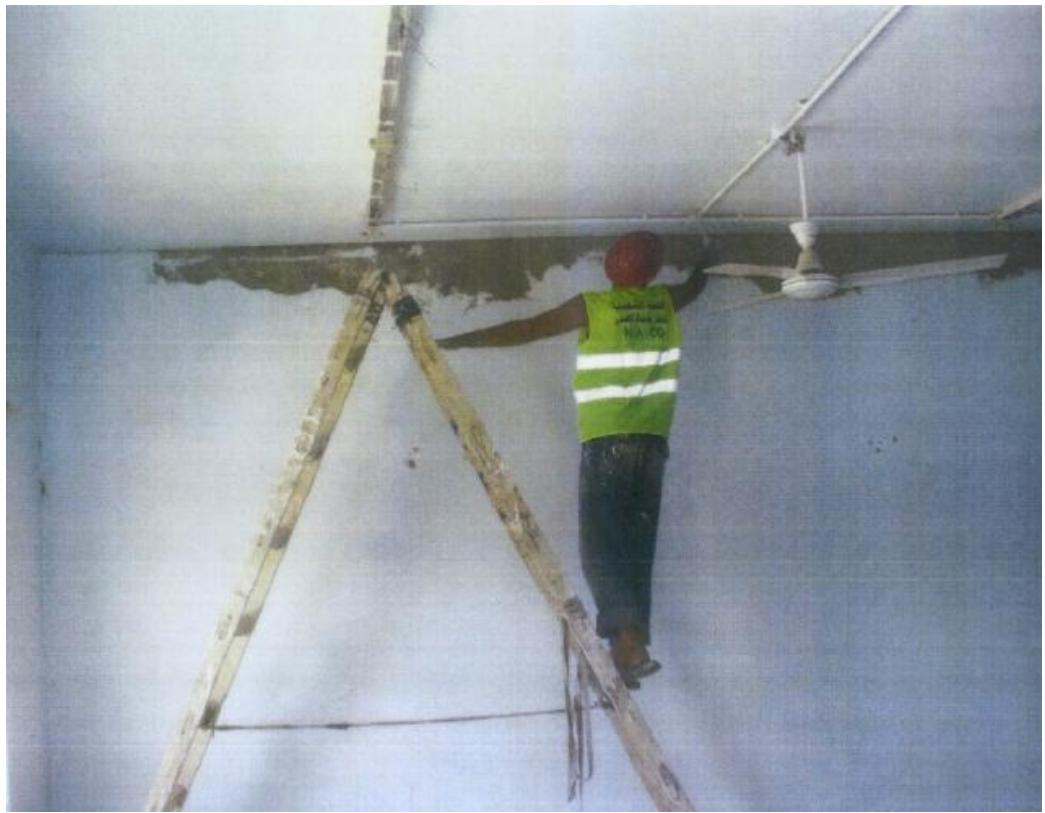
Site Photo 4. Reworking electrical lines & installing fan at Al Quds (Photo courtesy of MNC-I)

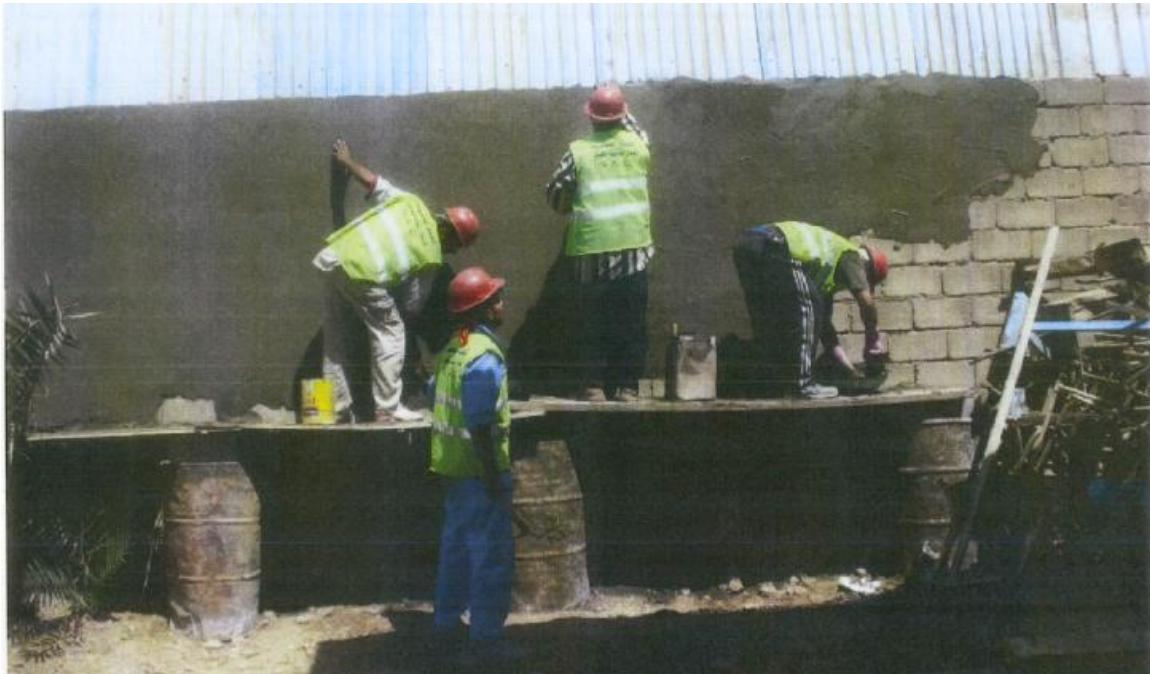
The Al Mualameen School photographs show the plastering of the wall (Site Photo 5) and the painting of the exterior wall surrounding (Site Photo 6).

Site Photo 5. Plastering the wall at Al Mualameen (Photo courtesy of MNC-I)

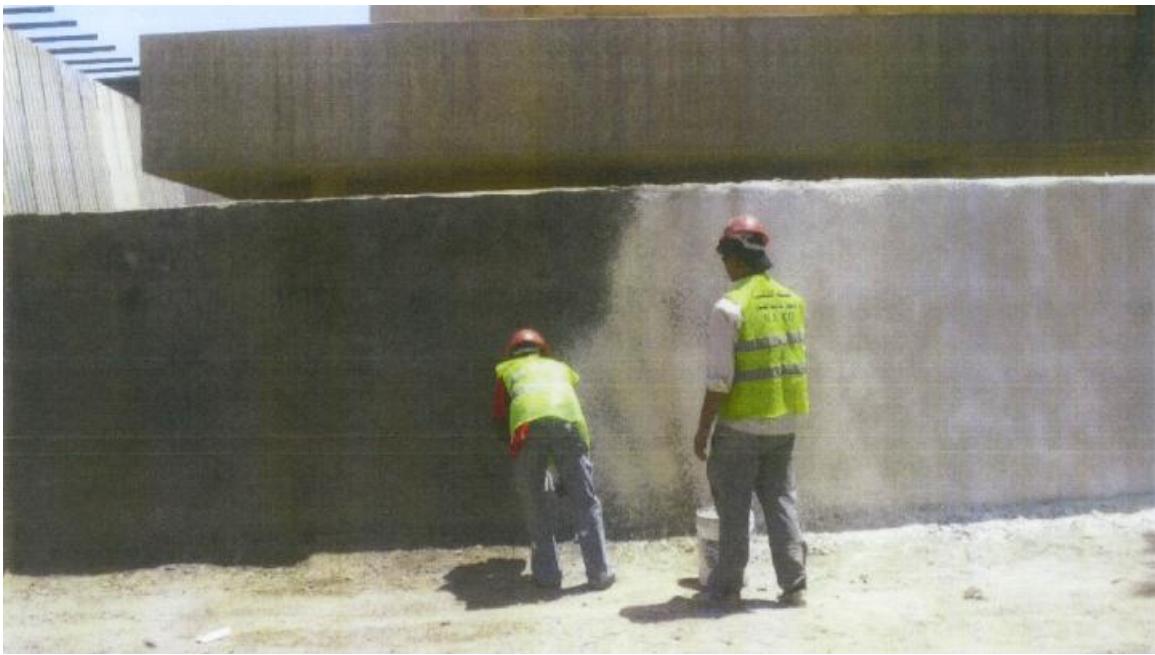
Site Photo 6. Repairing the wall at Al Mualameen (Photo courtesy of MNC-I)

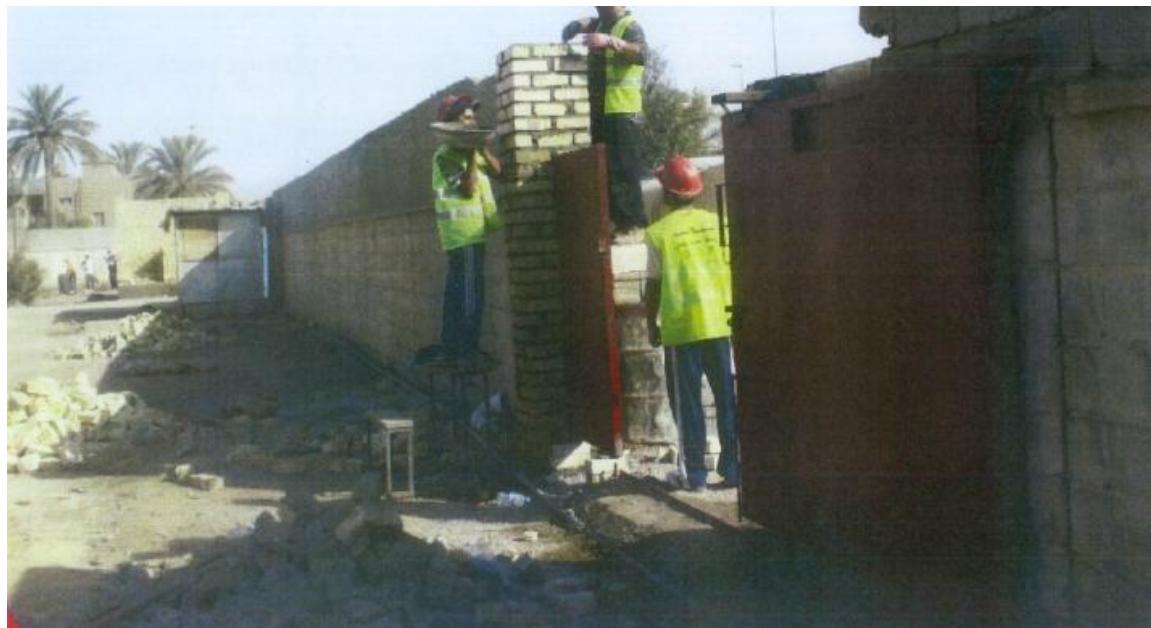
Al Faoo School photographs show plastering of the exterior wall surrounding the school (Site Photo 7), and the plastering and painting of the Al Faoo School's exterior (Site Photo 8).

Site Photo 7. Repairing wall at the Al Faoo school (Photo courtesy of MNC-I)

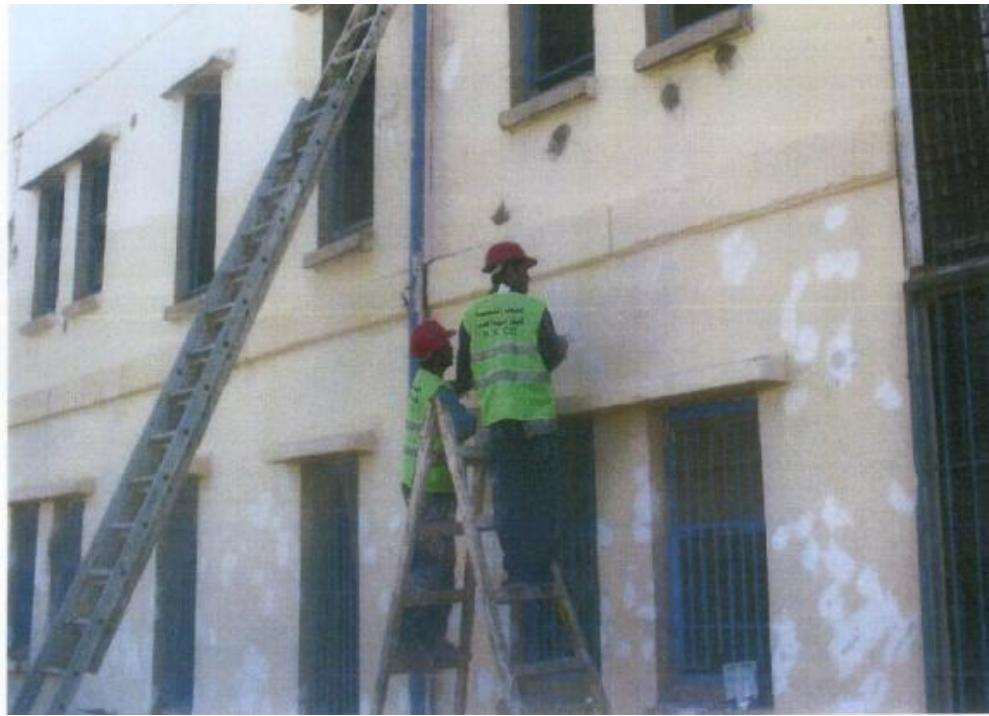
Site Photo 8. Plastering and painting the Al Faao school exterior (Photo courtesy of MNC-I)

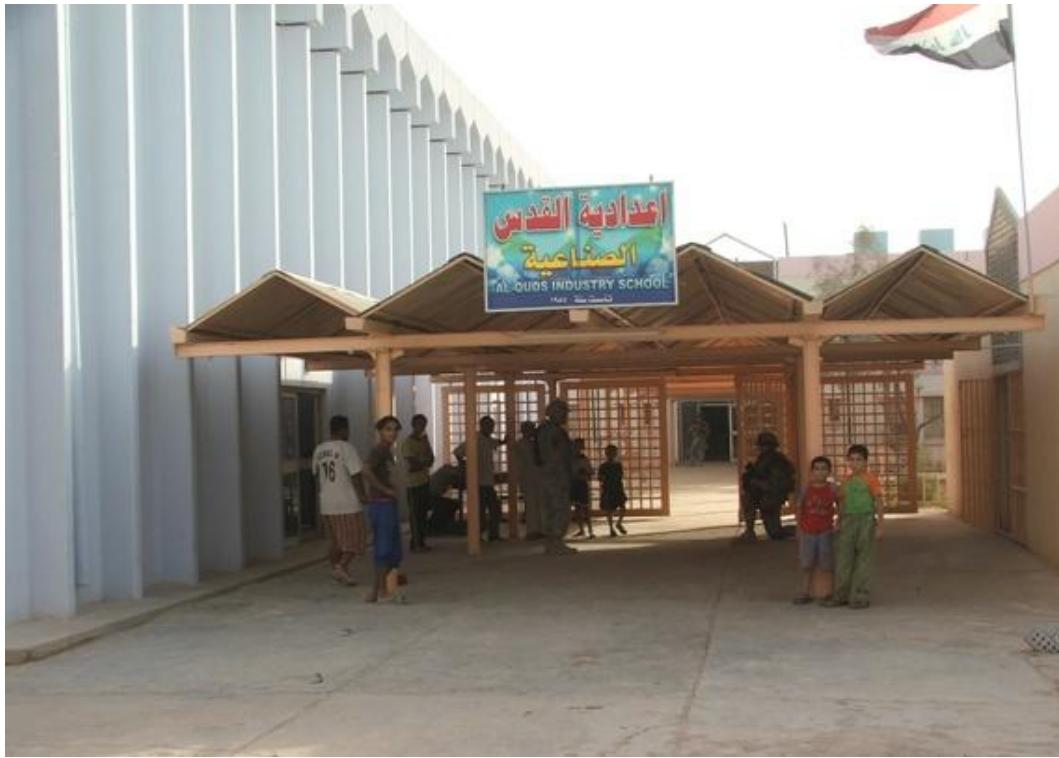
Site Photo 9. Al Quds School sign

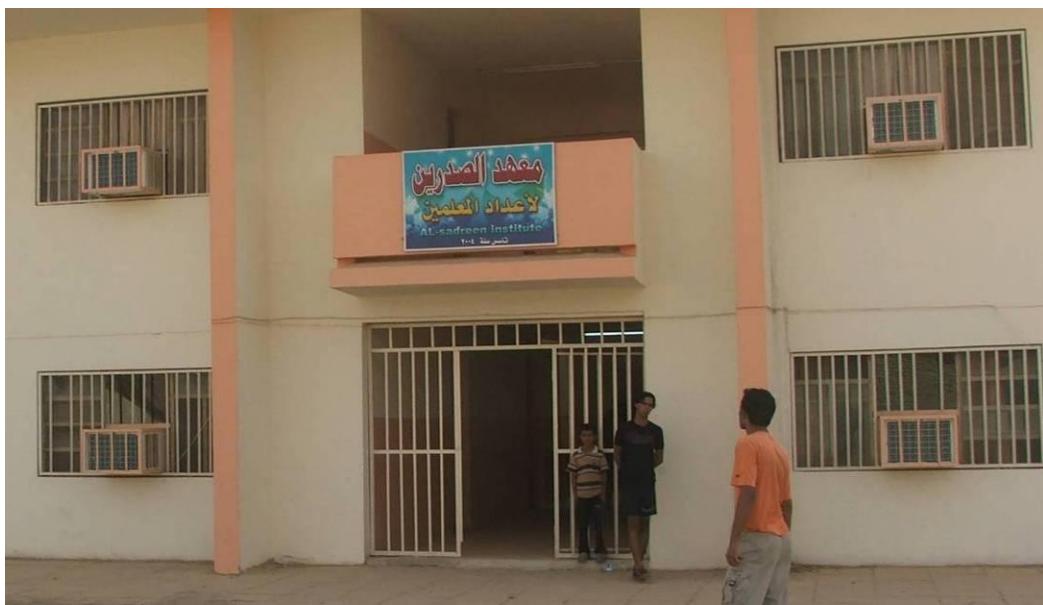
Site Photo 10. Al Mualameen School sign

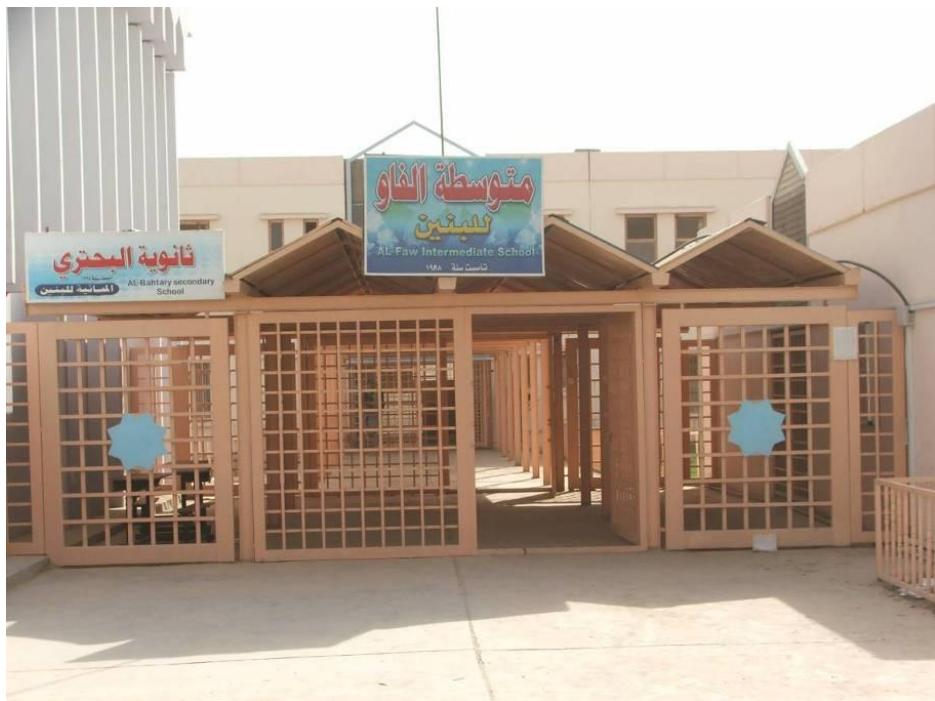
Site Photo 11. Al Fao School sign

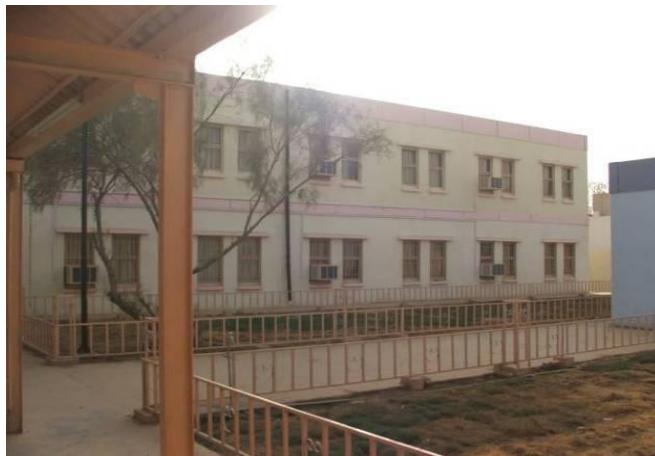
Site Photo 12. Painted exterior (Al Quds)

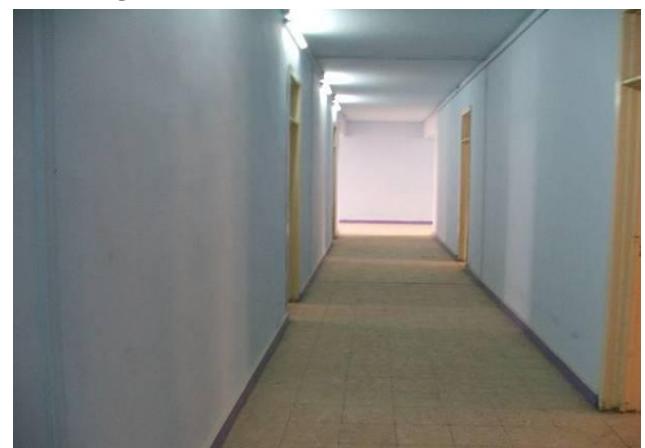
Site Photo 15. Painted interior (Al Quds)

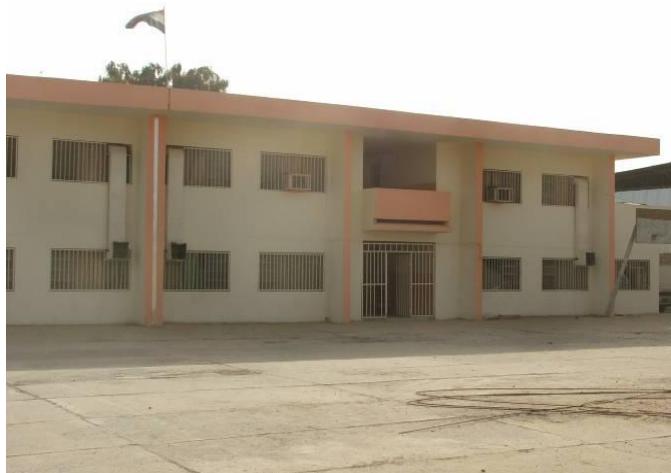
Site Photo 13. Painted exterior (Al Mualameen)

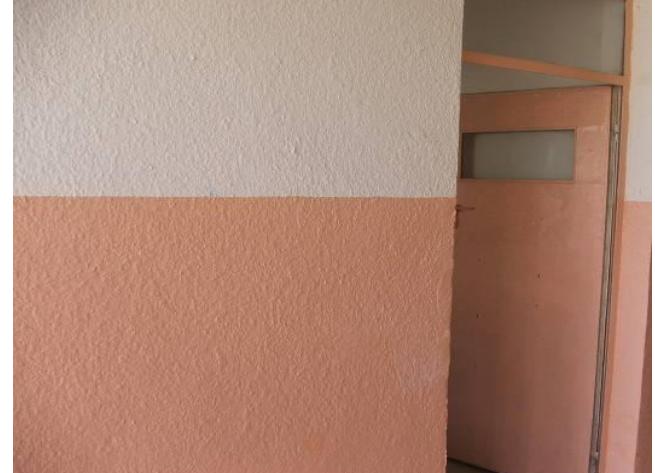
Site Photo 16. Painted interior (Al Mualameen)

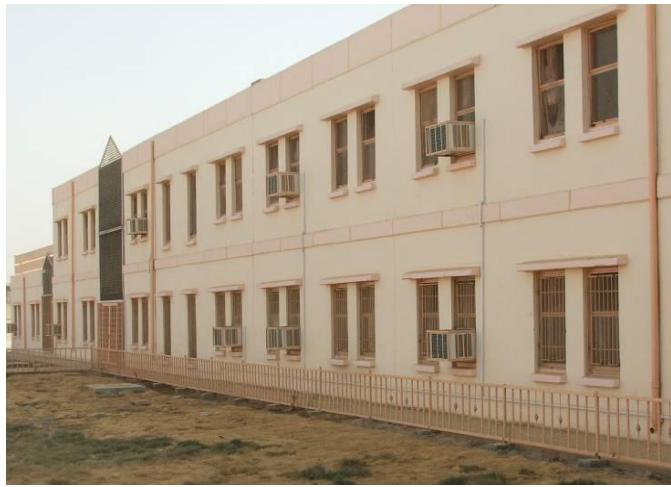
Site Photo 14. Painted exterior (Al Fao)

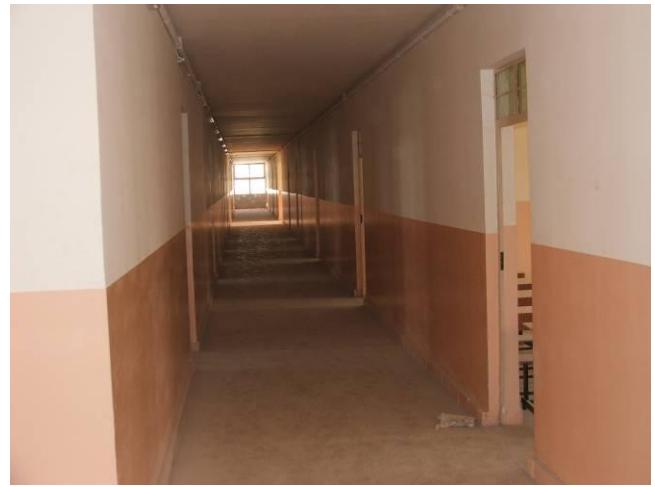
Site Photo 17. Painted interior (Al Fao)

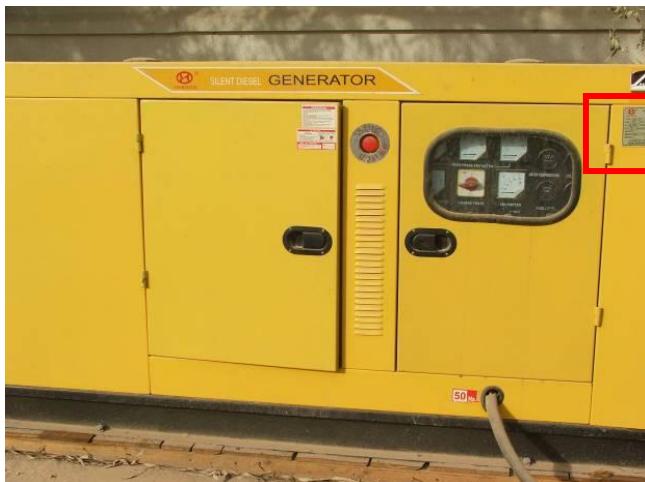
Site Photo 18. Generator (Al Quds)

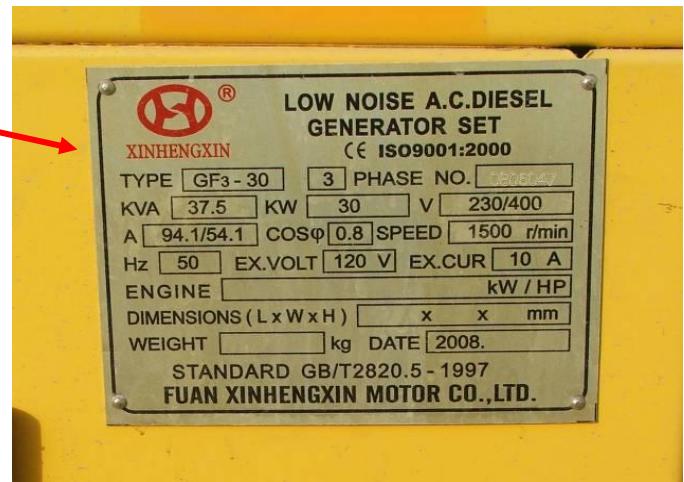
Site Photo 21. Generator ID (Al Quds)

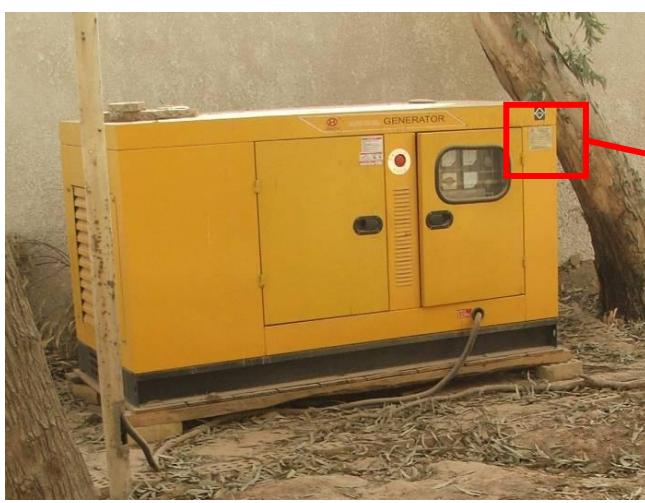
Site Photo 19. Generator (Al Mualameen)

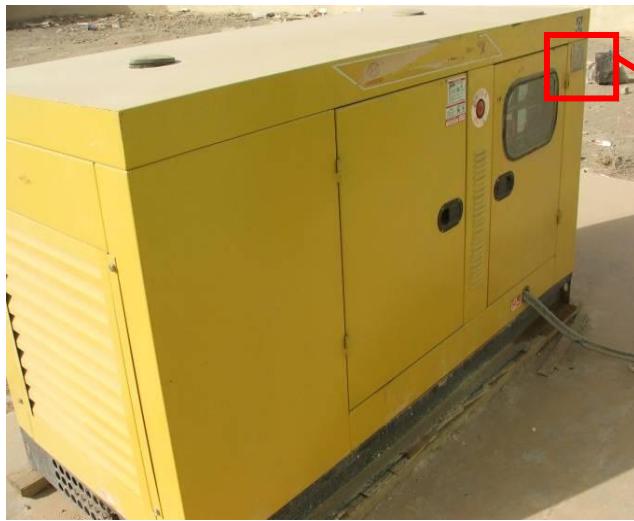
Site Photo 20. Generator (Al Faoo)

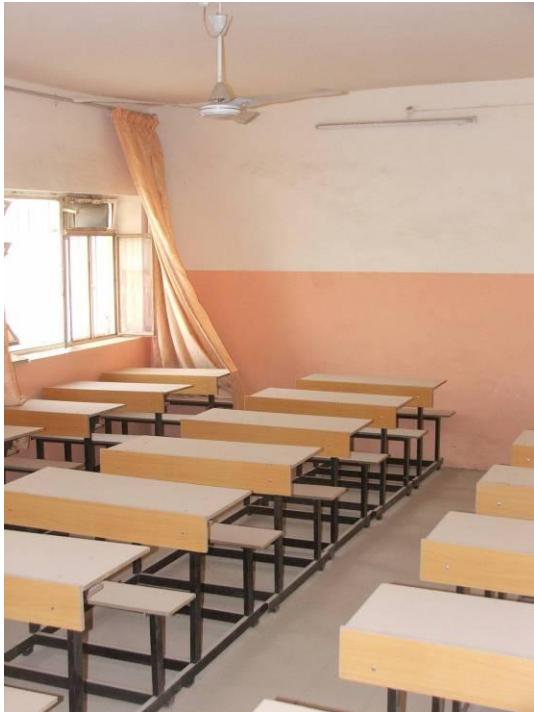
Site Photo 24. Desks (Al Mualameen)

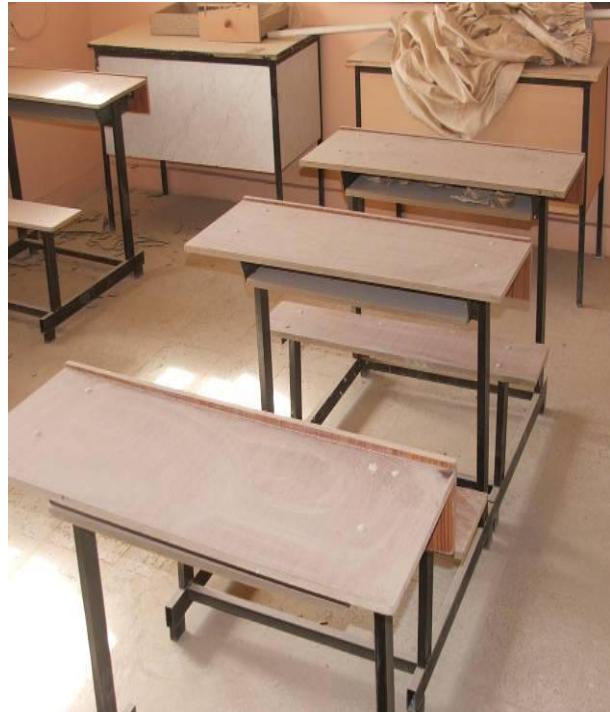
Site Photo 25. Desks (Al Faoo)

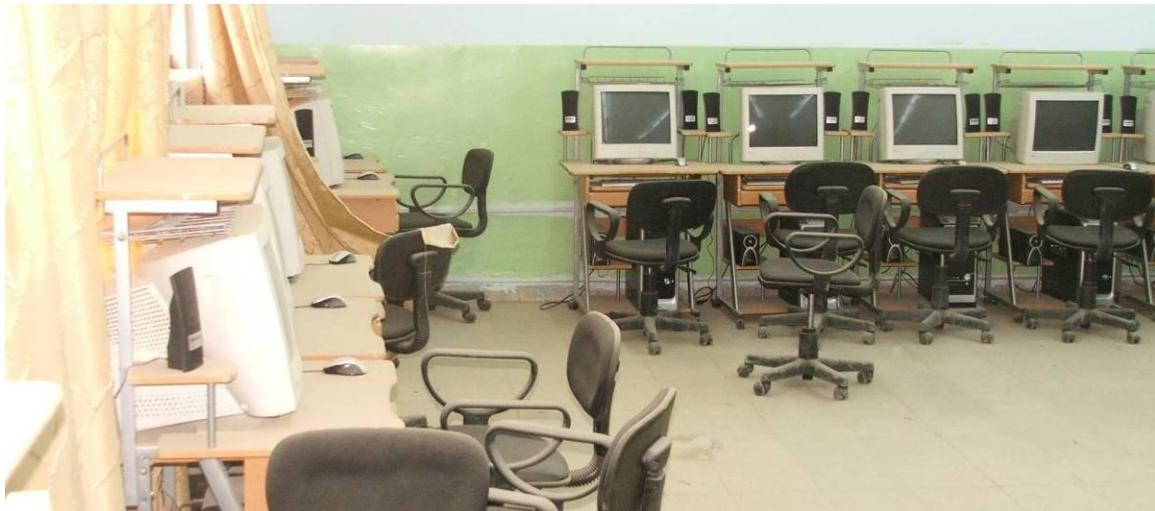
Site Photo 27. Computer room (Al Quds)

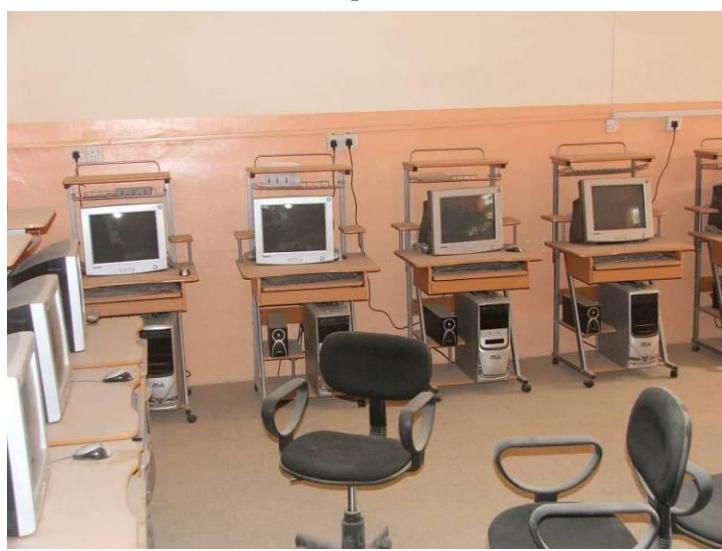
Site Photo 28. Computer room (Al Mualameen)

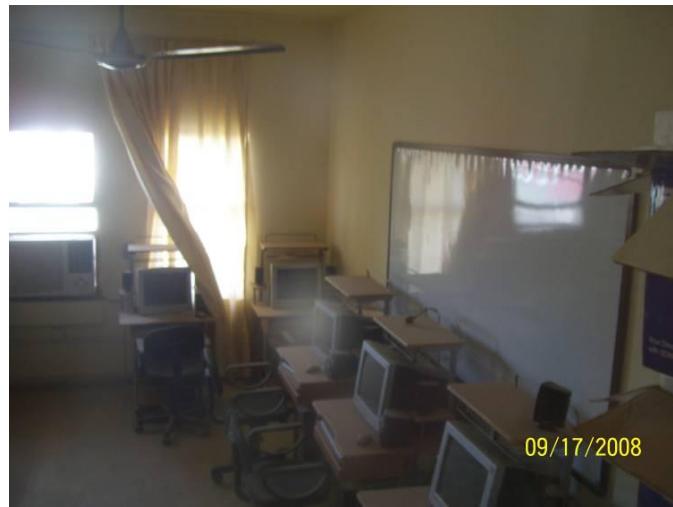
Site Photo 29. Computer room (Al Faoo)

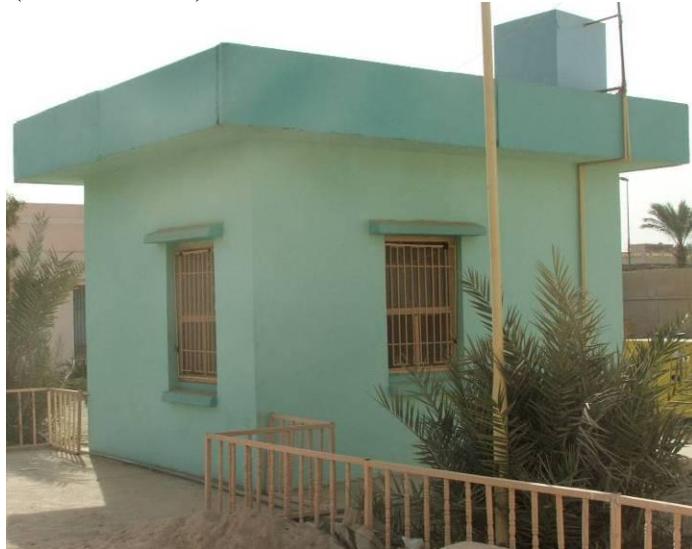
The contractor repaired the caretaker building (Site Photo 30), and the exterior fence and gate of the school (Site Photo 31).

Site Photo 30. Caretaker building (Al Faoo)

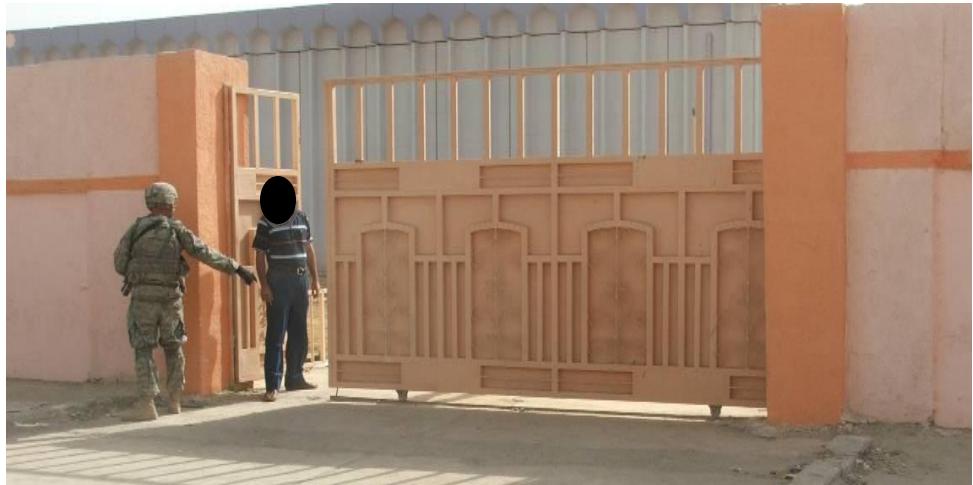
Site Photo 31. Exterior fence and gate (Al Faoo)

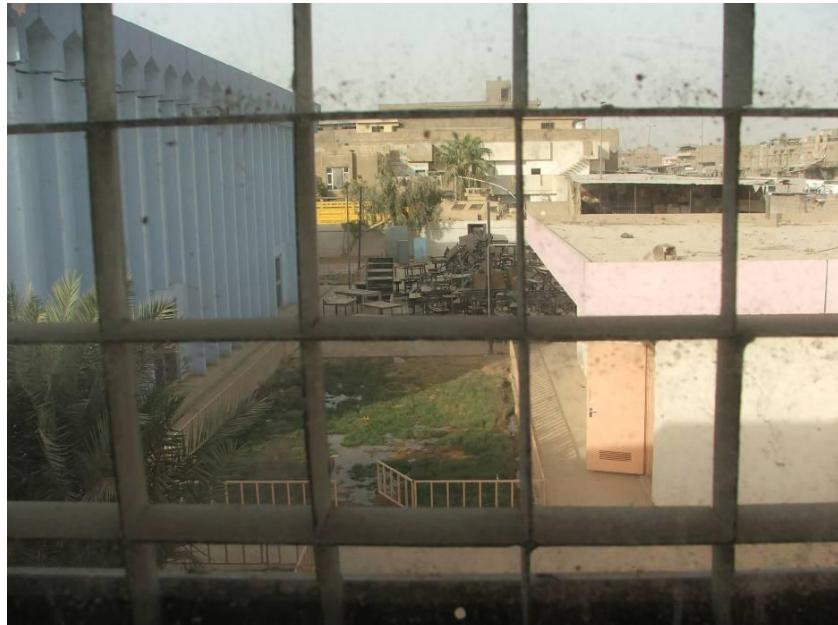
The SIGIR inspectors found that the school rehabilitations were near completion. However, not all the screens were installed in the school windows (Site Photo 32). Some of the air conditioners were not working properly. The electrical panel was not located in a secure area inaccessible to the students and all electrical wiring was not in conduits (Site Photo 33). Also, there was no evidence that the school supplies had been provided.

Site Photo 32. No screens in windows (Al Quds)

1. Initiate another contract to complete the school refurbishments, particularly portions of the contracts that present safety issues such as the electrical panel, which presents a risk of electrical shock and fire, and the debris and discarded furniture, which present an unsafe condition. In addition, the warranty, which is no longer valid from the original contractor, should be addressed, as well as incomplete items from the original contracts such as the missing window screens, inoperable air conditioning units, undelivered school supplies, etc.

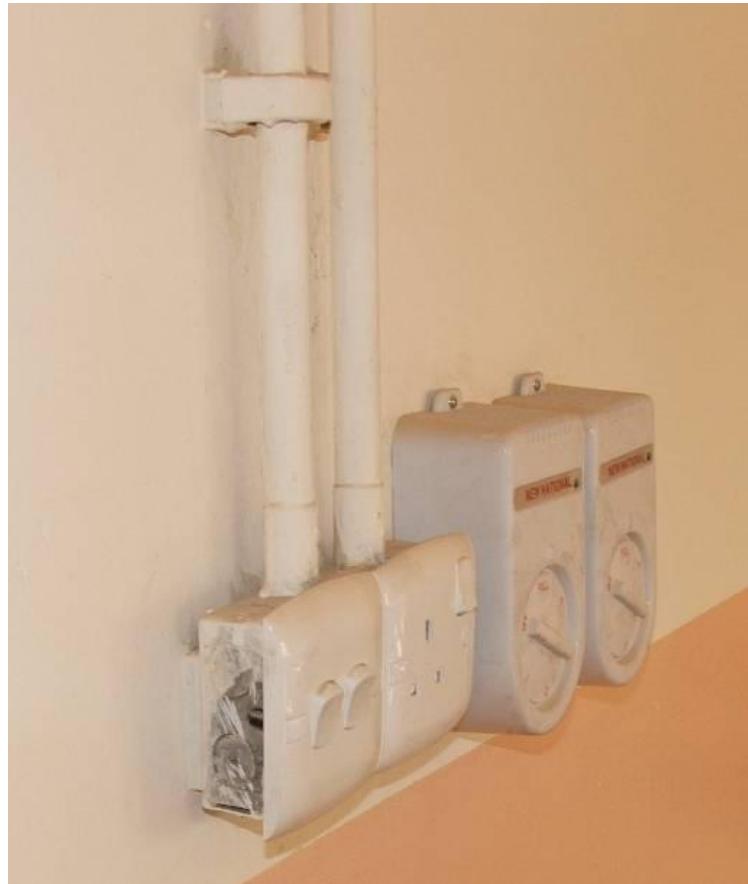
In the Al Faoo School, the contractor installed the electrical switches and thermostat controls properly (Site Photo 34). There was evidence of poor quality electrical installation by the contractor (Site Photo 35) and an improper electrical connection (Site Photo 36) at the Al Mualameen School. The contractor needs to rewire the connections to the proper power supply.

Site Photo 34. Proper electrical installation (Al Faoo)
(Note: Paint not fully applied to side of electrical box).

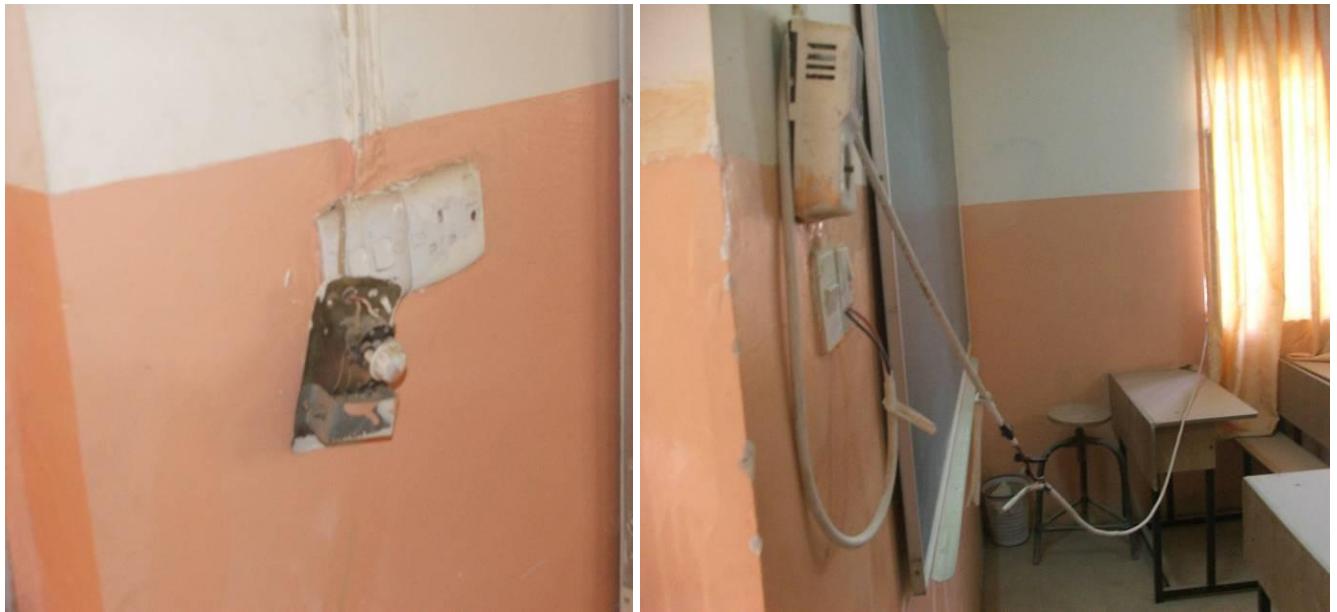
**Site Photo 35. Poor electrical installation
(Al Mualameen)**

**Site Photo 36. Improper electrical connection
(Al Mualameen)**

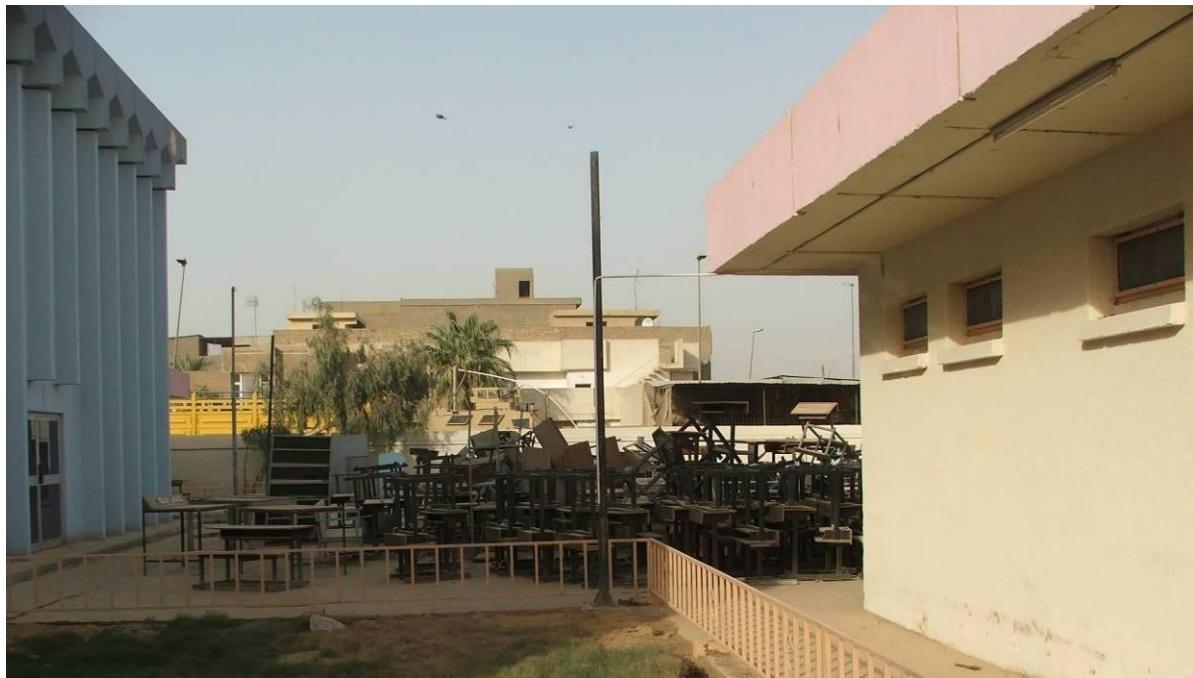
The school grounds were not being maintained and a recent sand storm had created a blanket of sand/dust on most surfaces. Also, debris and old furniture were present on the school grounds (Site Photo 37). The debris (Site Photo 38) and old furniture left on the site is a hazard to students and should be removed. If the school wishes to keep some of the old desks for replacement, the desks should be stored properly.

Site Photo 37. Old furniture and debris (Al Quds)

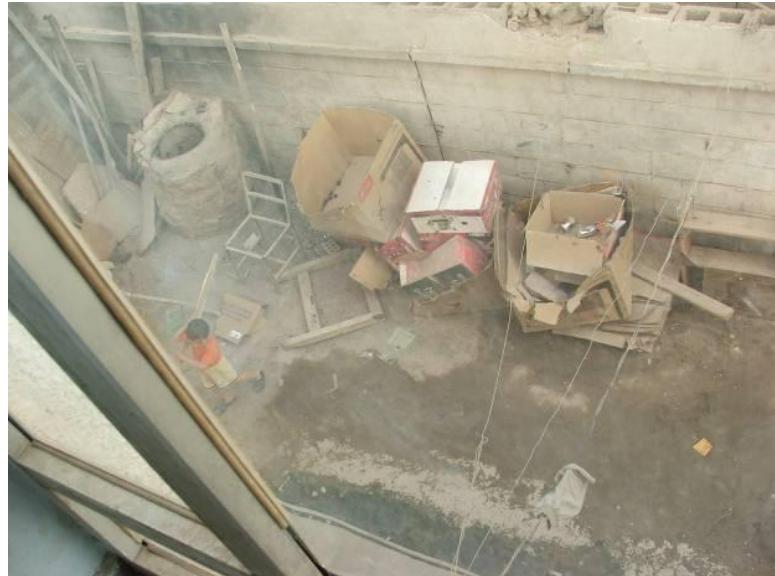
Site Photo 38. Site debris (Al Quds)

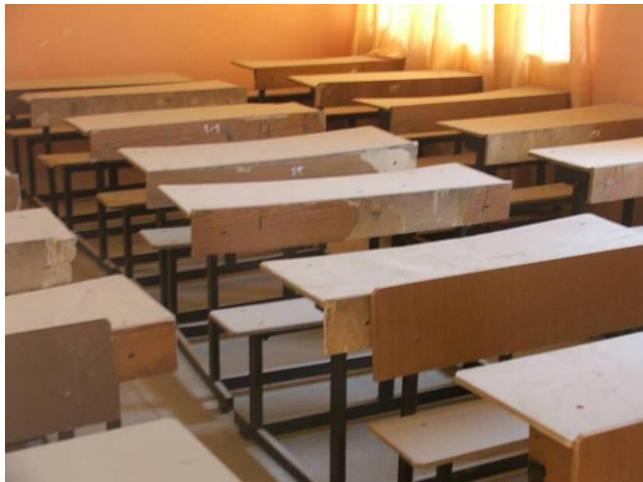
Site Photo 39. Broken desks (Al Mualameen)

The new contractor will need to remove the old desks left in the schoolroom (Site Photo 39) and repair the broken steps (Site Photo 40).

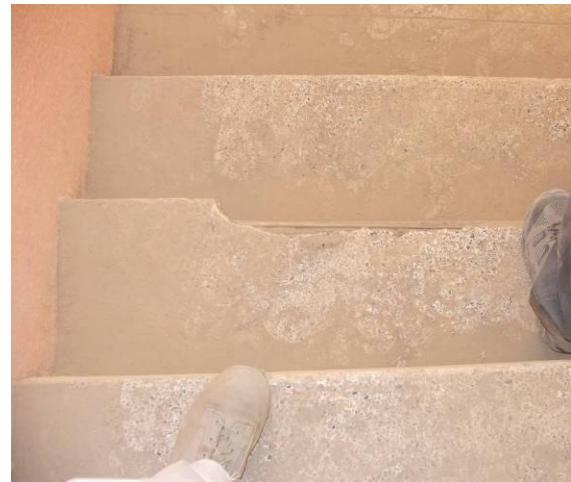
Site Photo 40. Broken stairs (Al Mualameen)

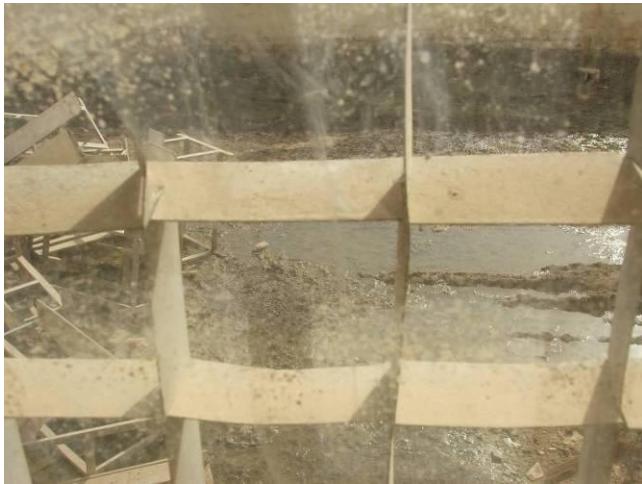
Site Photo 41. Exterior debris (Al Faoo)

In addition, the new contractor will need to clean the exterior debris (Site Photo 41) and complete refurbishing the second floor of the Al Fao School, which had discarded books scattered throughout the classrooms (Site Photo 42), broken desks throughout the classrooms (Site Photo 43), and miscellaneous debris in the school rooms (Site Photo 44).

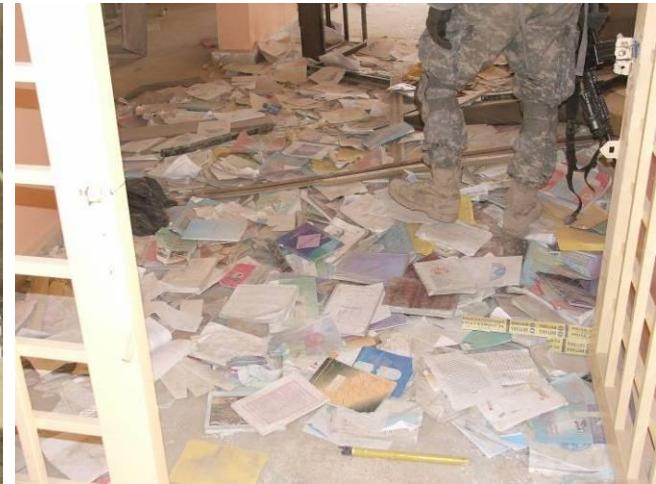
Site Photo 42. Discarded books (Al Faoo)

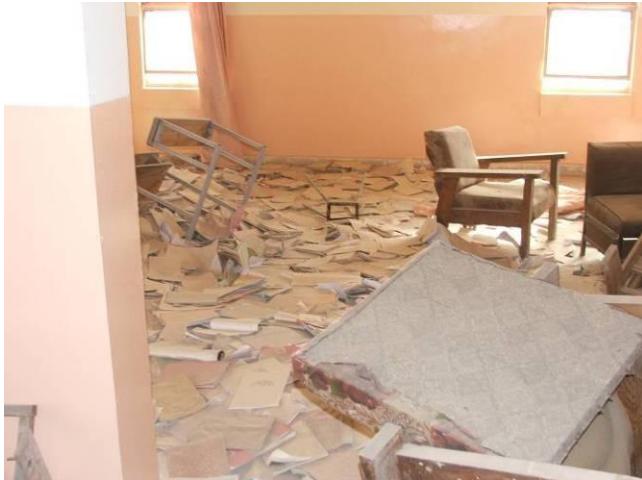
Site Photo 43. Broken desks (Al Faoo)

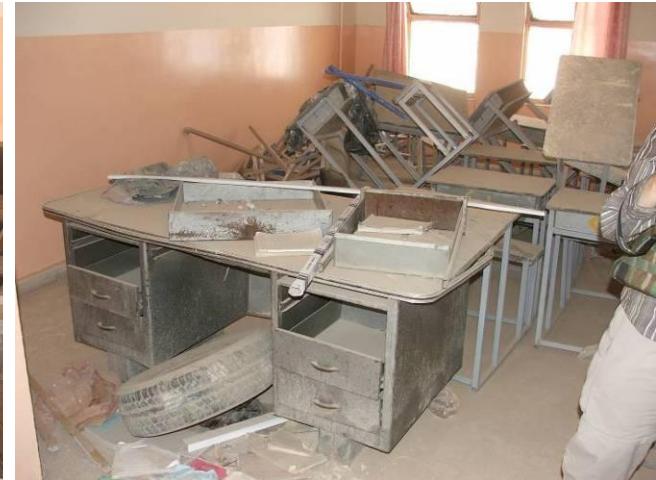
Site Photo 44. Unfinished 2nd floor (Al Faoo)
